# MARINE STRUCTURES

## THEIR DETERIORATION AND PRESERVATION

REPORT

COMMITTEE ON MARINE PILING INVESTIGATIONS  
*of the* DIVISION OF ENGINEERING AND INDUSTRIAL  
RESEARCH *of the* NATIONAL RESEARCH COUNCIL

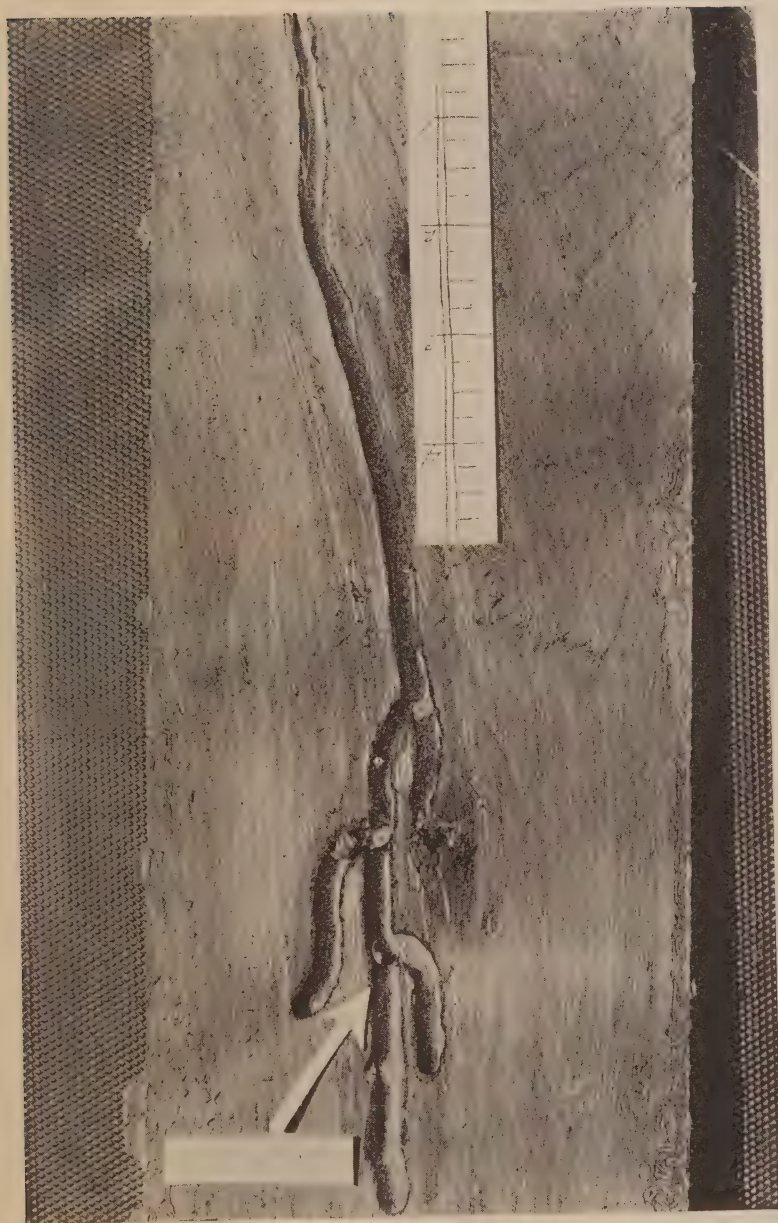
not normal, being less in diameter and longer than usual. They had no difficulty in crossing from one shingle to another, but except in a few cases seemed to prefer to stay in one shingle as long as possible. In one or two cases they seemed to work freely at right angles to the face of the shingles, and were then more nearly normal in shape (Fig. 5).

FIG. 5—BURROW OF *Teredo bartschi*; IN SHINGLE BLOCK FROM PORT EADS, I.A.

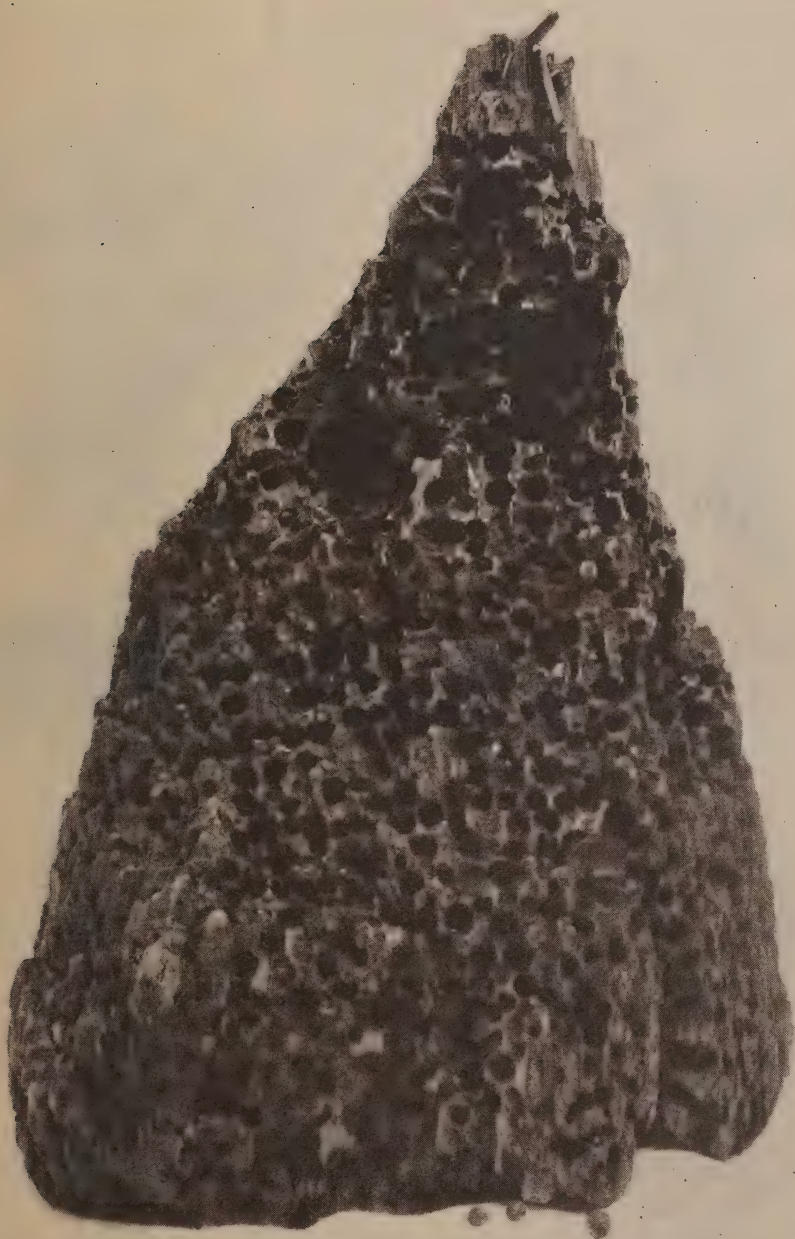
FIG. 12.—SECTION OF PILE FROM FLORIDA EAST COAST RY. BRIDGE, ST. JOHNS RIVER, PALATKA, FLA. *Sphaeroma* ATTACK—17 YEARS' SERVICE.

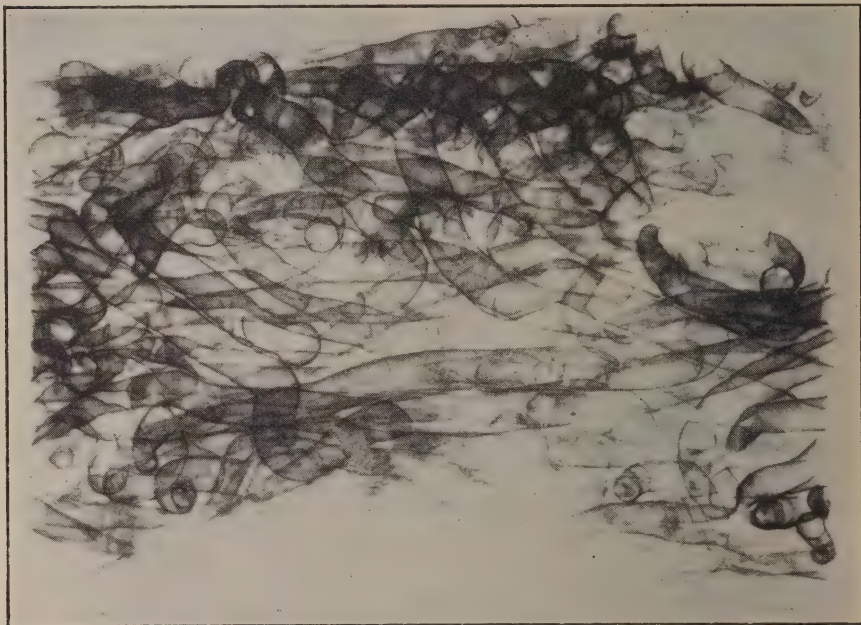
The method of attack and general appearance of the first two genera are similar (Fig. 13). The two valves of the shell function as a highly specialized boring mechanism; the long slimy worm-like body fills the burrow, which is lined with a calcareous coating, and both *Teredo* and *Bankia* are supplied with very long siphons and with so-called "pallets."

FIG. 13—X-RAY PHOTOGRAPH OF TIMBER ATTACKED BY TEREDINE BORERS

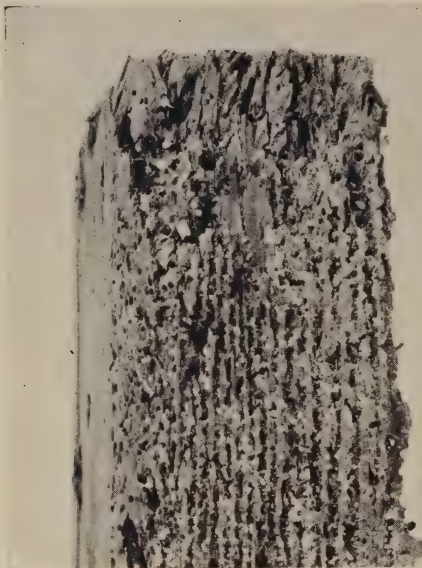
FIG. 6

- FIG. 6. Portion of a  $3\frac{1}{2}$ " x  $3\frac{1}{2}$ " x 6" test block submerged 8 months at Tutuila, showing damage done by *Limnoria andrewsi* and *Chelura insulae*. The ends of a few *Teredo* burrows have been exposed. x  $\frac{3}{4}$ .  
7. All that remained of a 2" x  $3\frac{1}{2}$ " x 5" test block submerged 8 months in Honolulu Harbor. The major damage was occasioned by *Limnoria andrewsi*; *Limnoria lignorum* and *Chelura insulae* were also present in the block. All *Teredo* were dead as a result of exposure of their burrows by the crustacean borers. x  $\frac{3}{4}$ .  
8. Portion of block from Tutuila, showing specimens of *Chelura insulae* in place in burrows. One *Limnoria andrewsi* is seen in place near lower left corner. x 5.

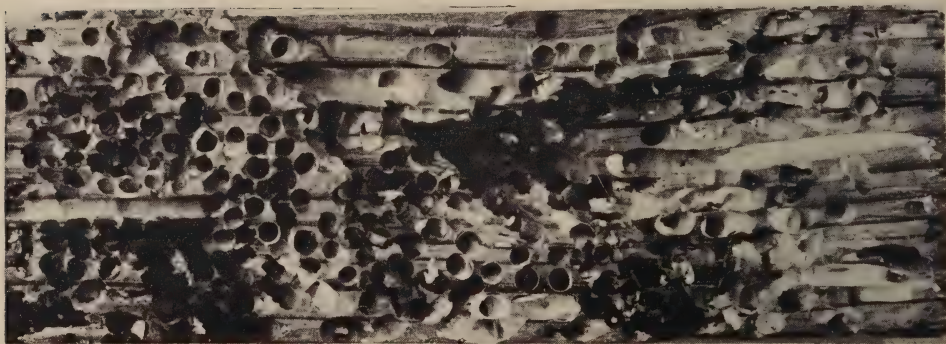
FIG. 41

- FIG. 38. Pallets of *Teredo bartschi*, dry, showing distorted chitinous portion. x 10.  
 39. Pallets showing normal condition of the chitinous portion. Type, Mus. Comp. Zool., No. 45301. x 12.  
 40. Pallets showing position in relation to the internal lamellae of the tube. x 10.  
 41. Destruction caused by *Teredo bartschi* in test block submerged eight weeks. Natural size.

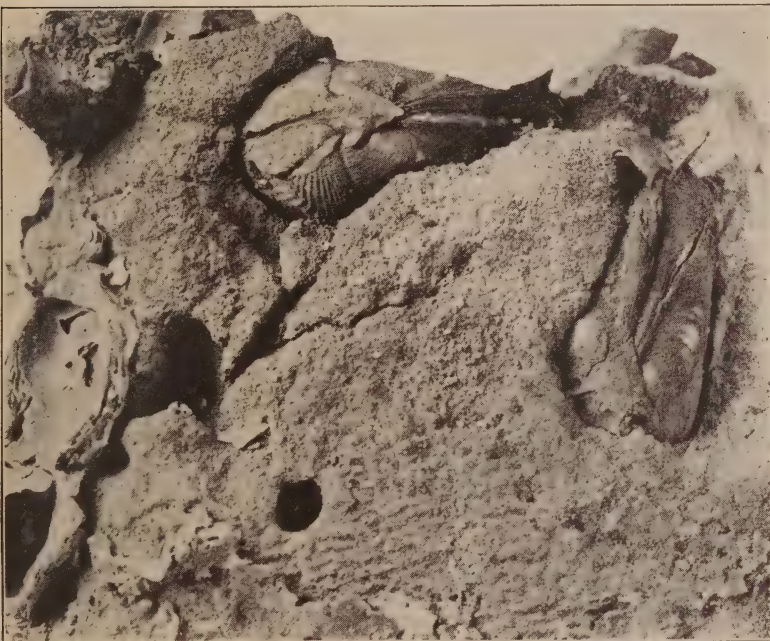
"The species occasioning most of the damage was found to be *Pholadidea penita* Conrad, known commonly as the "rock clam." (Fig. 18.) It occurred from two feet above mean low water to one foot below, which was the lowest level at which we were able to work. It doubtless similarly occurs on down to the mud, even in deep water, as it has been dredged in San Francisco Bay at a depth of fifty fathoms.

"As regards extent of the damage occasioned by borers in concrete, a review of the data assembled by Mr. Hughes, Mr. Ludlow, Mr. Sadler and Dr. Miller, indicates that, of concrete jacketed piles at four different locations in Los Angeles Harbor, in fact at every point in the inner harbor where such piles exist, about 50 per cent have been more or less attacked, of which rather more than one-fifth have been very considerably bored. Of those not attacked, a number stood so well inshore as to be but little exposed to the action of the borers. If all such piles were eliminated from the count, the percentage of jackets damaged would be considerably higher.

FIG. 18—PHOLADS IN CONCRETE CASINGS AT LOS ANGELES, CAL.

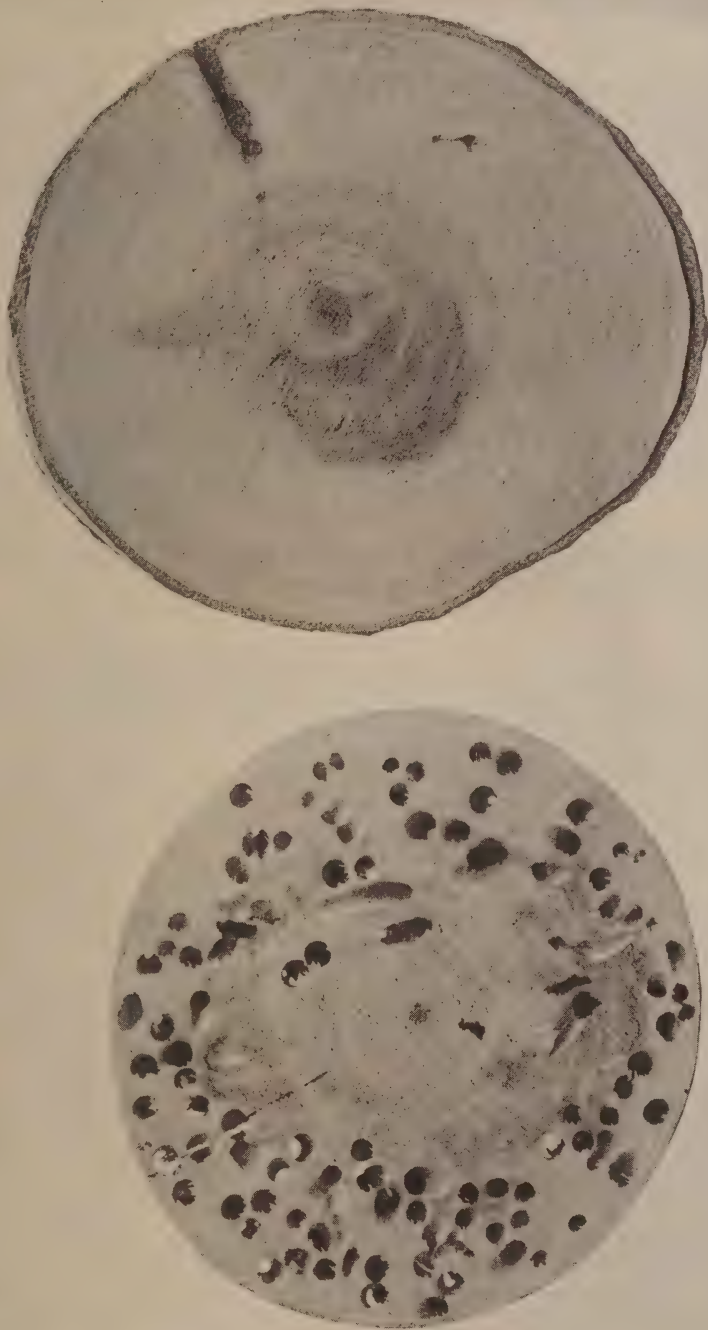
FIG. 20—SECTIONS OF BARKED AND UNBARKED COTTONWOOD TEST PIECES IMMERSSED AT PIER 1, NORTHERN PACIFIC RY., SEATTLE, SEPTEMBER 27, 1923 AND REMOVED JANUARY 28, 1924

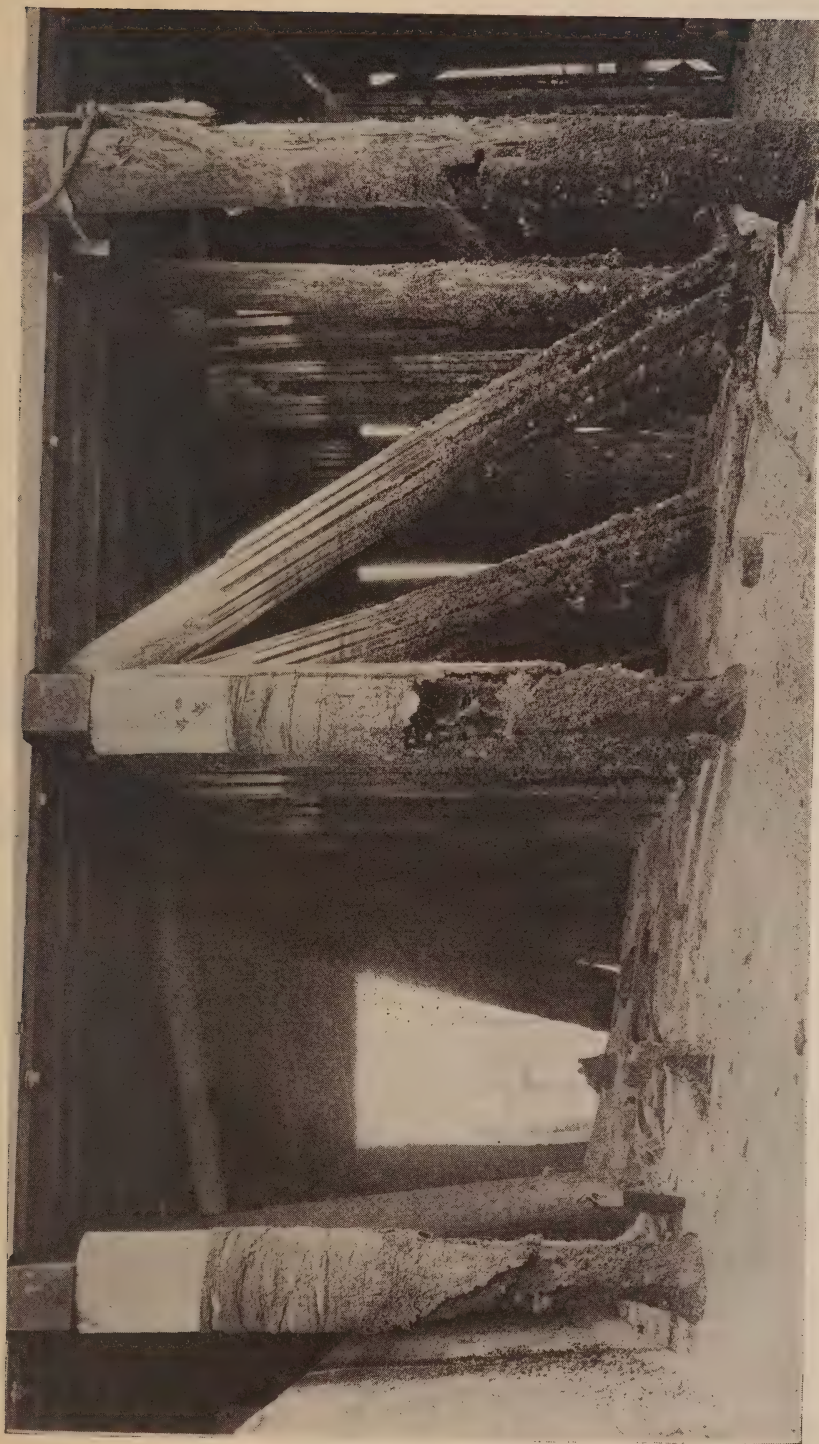
The Coaling Pier and the Main Station Pier at the Puget Sound Navy Yard were built on Perfection piles between 1901 and 1904, and the two piers still contain 332 of these piles, a slightly larger percentage than in the Northern Pacific piers. This is accounted for by the better protected site at the Navy Yard and perhaps the fact that some of these piles were further protected by tarred or creosoted battens. It is, however, stated that the coating on most of these piles remaining is broken and that the piles have been attacked (Fig. 21).

FIG. 21.—PERFECTION PILES DRIVEN IN 1903 IN COAL WHARF AT THE PUGET SOUND NAVY YARD.

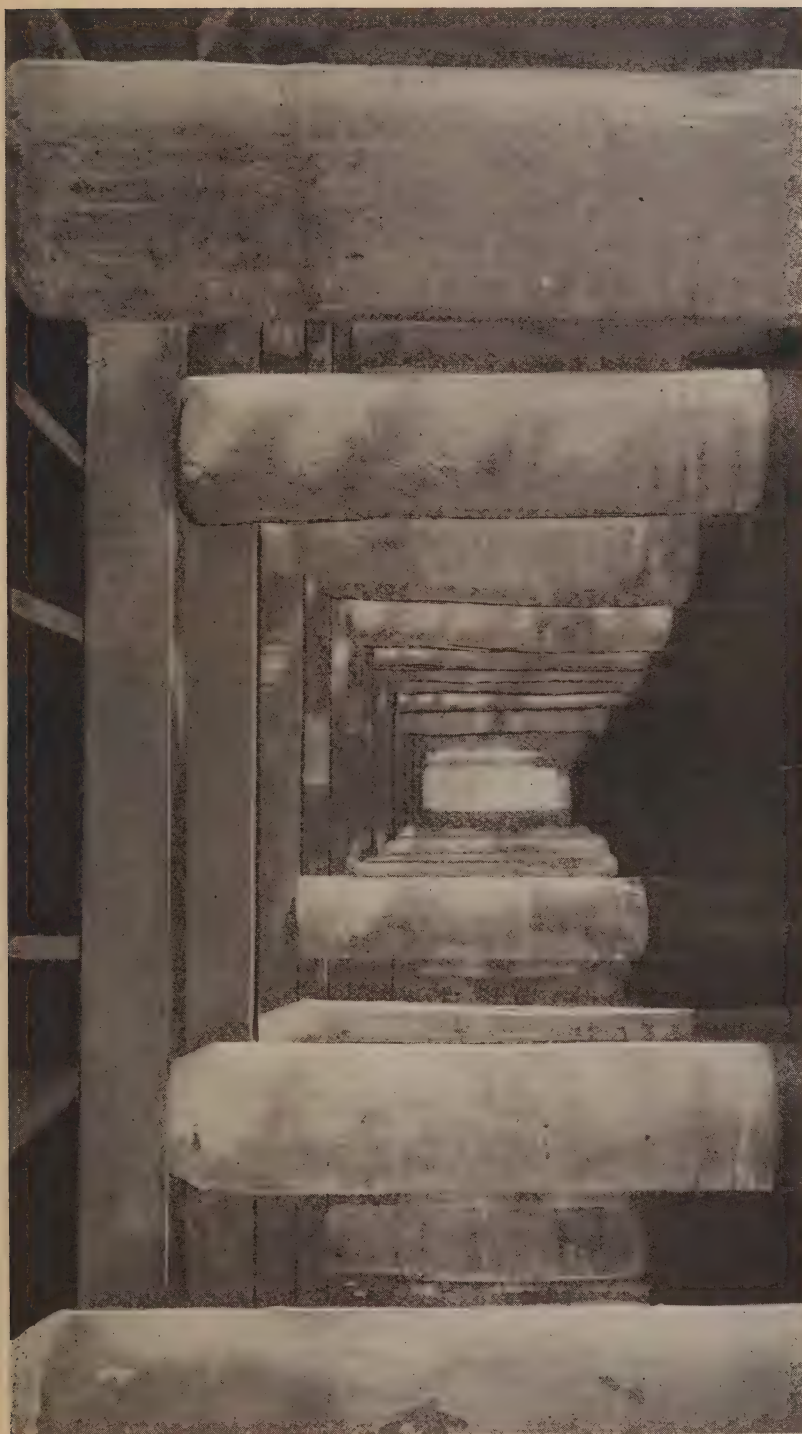
The casings, reinforced with heavy wire mesh, were built up in sections about 2 feet 6 inches in length on collapsible metal forms with a cement gun. The lowest section had a canvas gasket with steel fingers which fitted the pile sufficiently tight to retain the concrete poured into it after it was placed on the pile. The piles were cut off about 5 inches under the deck of the pier, the lower section of the casing put in place, filled with concrete, and other sections added and filled with concrete as the casing was lowered, until it rested on the mud. It was then jacked down until about 3 feet of penetration was obtained and the upper end built up under the cap by the addition of more sections filled with concrete (Fig. 23). The cost of this work is stated to have been about \$2.50 per foot of pile.

FIG. 23—GUNITÉ CASINGS ON SHELL OIL Co.'s WHARF, MARTINEZ, CAL.

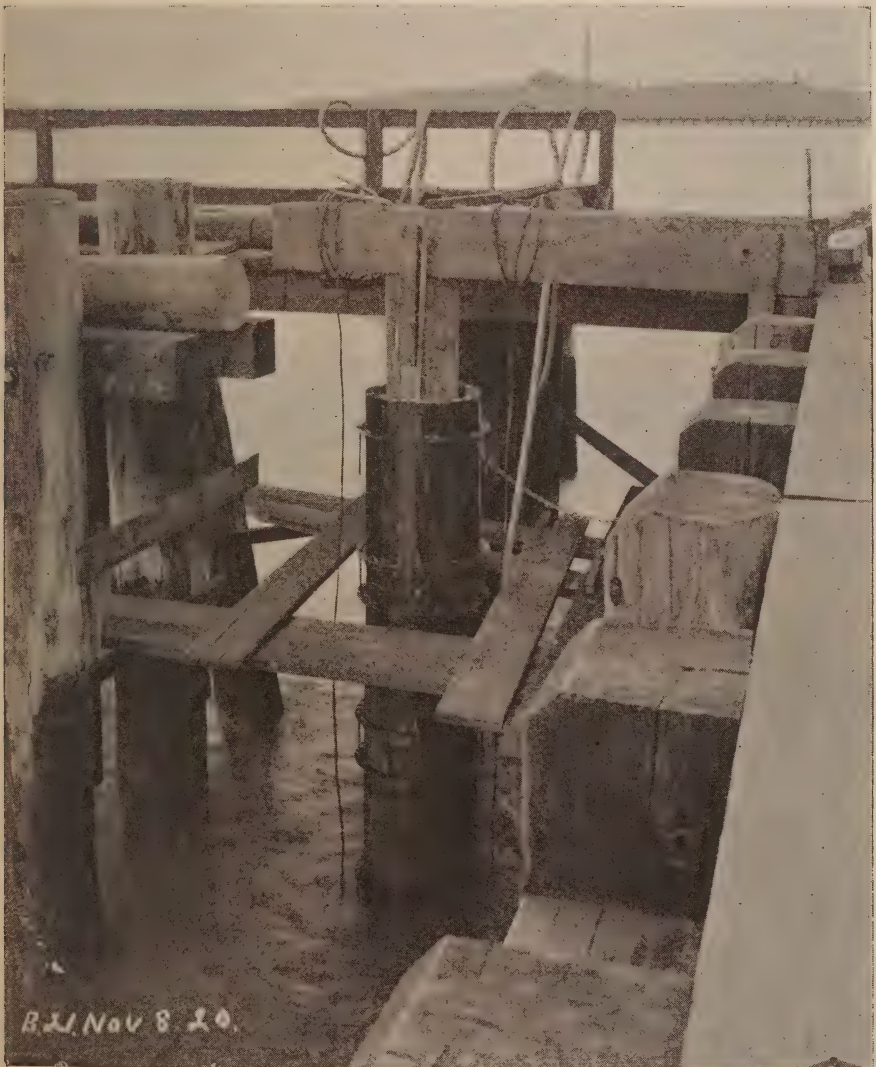
The Camp Process (patented) is typical of the construction of concrete jackets with removable forms (Fig. 24). Circular wooden forms are provided with sections 3 feet in length and about 20½ inches inside diameter, made of tongued and grooved wooden pipe staves strengthened with bands of angle iron. They are made in halves and each half is hinged in the center. When placed around the pile the halves are fastened together with tapered pins. The lower section is provided with sheet iron fingers over which canvas is fastened, and which touch the pile when the form is in place.

FIG. 24—FORMS IN PLACE FOR CONCRETE CASINGS CAST IN PLACE. "CAMP SYSTEM."

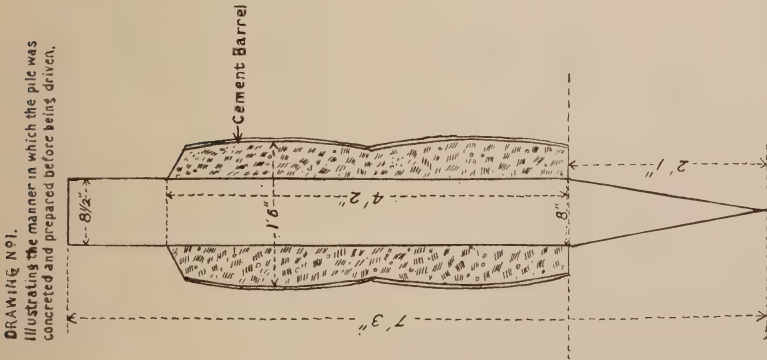
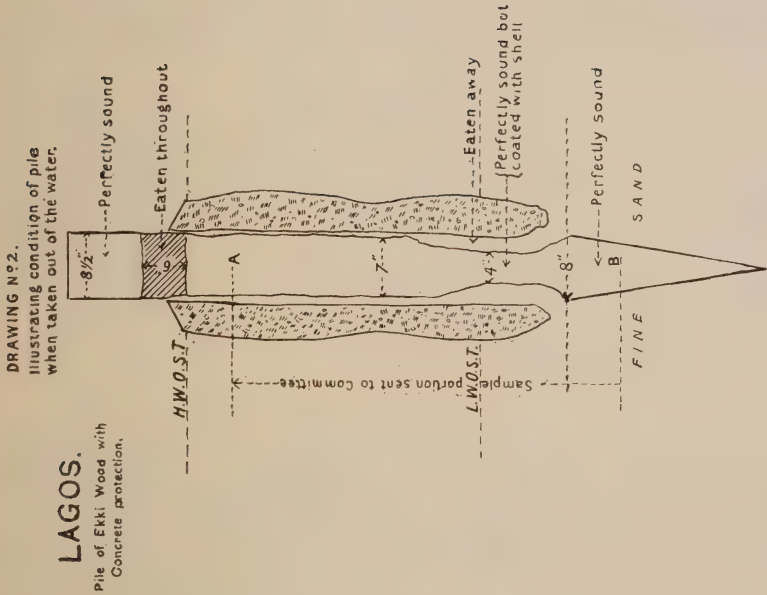
One of the frequent causes of failure of concrete cased piles, or piles with other types of mechanical protection, is the erosion of the bottom and the consequent exposure of the unprotected wood to attack. Fig. 25 shows a typical example taken from the report of the Institution of Civil Engineers, 1920, where the casing was too short on both ends. If casings are used, it is absolutely necessary that the bottom of the casing be not only below the mudline but far enough below so that there is no chance that scour will uncover unprotected timber, and the top should be above high water.

FIG. 25.—SKETCH SHOWING RESULT OF BUILDING CASINGS TOO SHORT.  
 (REPRODUCED FROM 1ST REPORT, INST. OF CIVIL ENGINEERS)

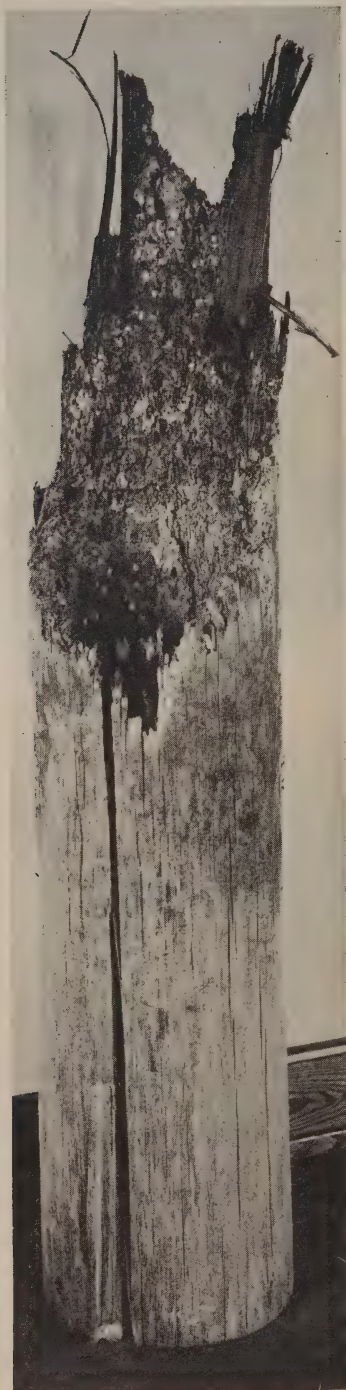
Specimen No. 4—From Pensacola Naval Station, Pensacola, Fla. Pine pile driven in 1902. (Fig. 26.) Specifications required absorption of 20 pounds of creosote per cubic foot. One hundred and ninety-eight piles in structure. In 1906 five piles were so badly damaged as to require renewal, and entire structure is now unsafe. Destruction was caused mainly by *Bankia* and *Limnoria*.

FIG. 26—SECTION OF PILE FROM PENSACOLA NAVY YARD SHOWING WORK OF MARINE BORERS.

One hundred and ninety-eight of these piles treated with 20 lb. per cu. ft. creosote were driven in 1902. At the end of three years five were badly attacked, necessitating the removal of two. Report of September, 1922, states that "all of the piles driven in the work are in such condition that quite a few have been broken off at about approximately water level by wave action. A large majority of the remainder can be broken off at the same level without much difficulty."

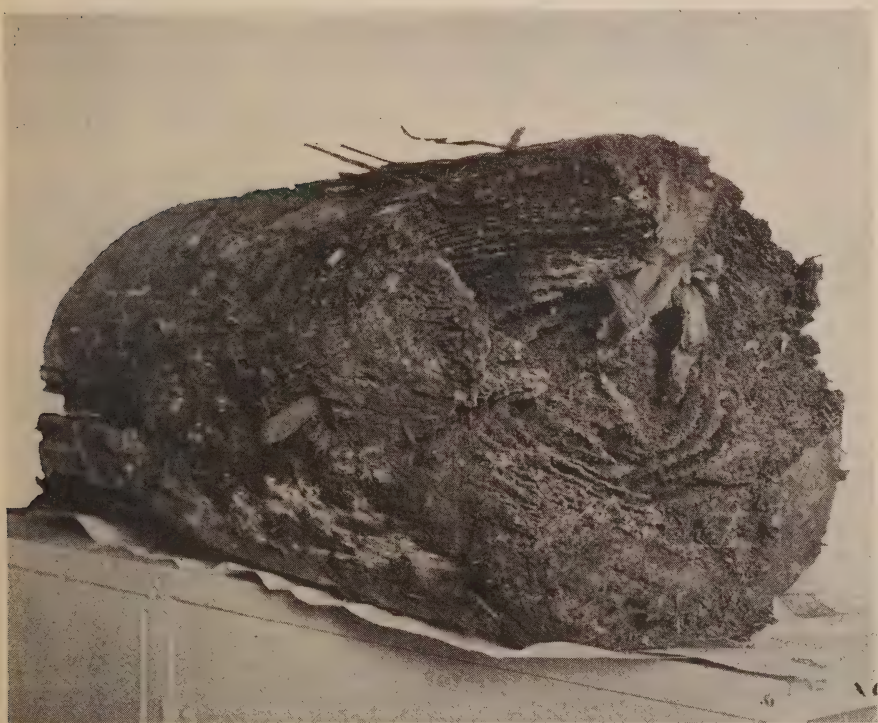
Specimen No. 8—From Lighthouse Pier at San Juan, Porto Rico. No record of treatment available. (Fig. 28). It had 8 years' service and was destroyed by *Limnoria*. It was cut up for other species and none were found.

FIG. 28—SECTION OF CREOSOTED PILE FROM LIGHTHOUSE WHARF, SAN JUAN, PORTO RICO, TAKEN FROM LOW WATER LINE.  
Built, 1898—Renewed, 1906

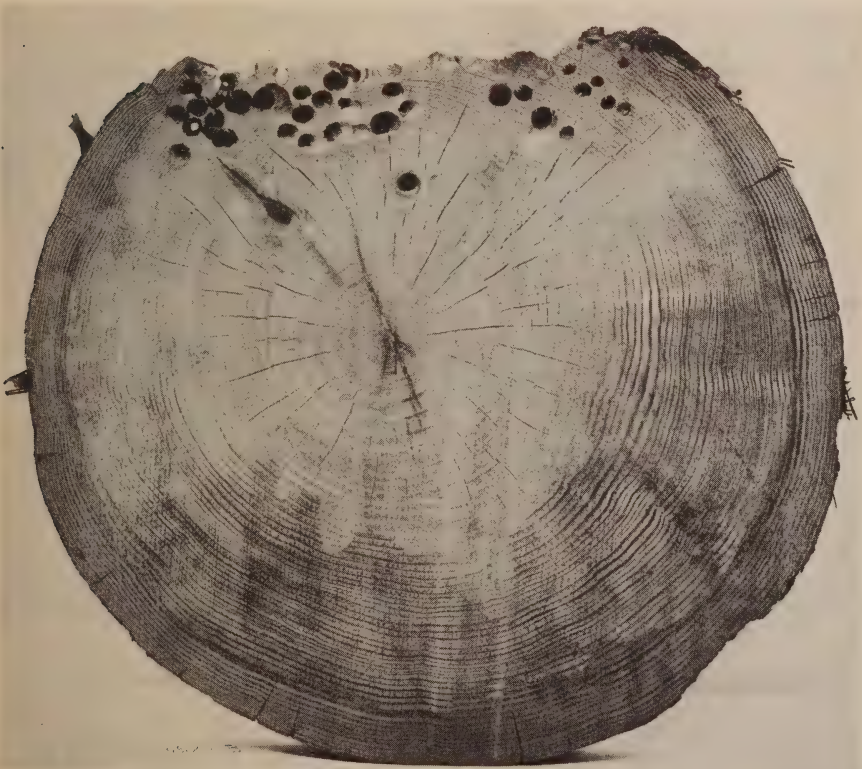
Specimen No. 9—Section of pine pile from foundation of 150-ton revolving crane at the plant of the Newport News Shipbuilding Company. (Fig. 29). These piles were treated by the Norfolk Creosoting Company in 1897 with a 16-pound treatment. The creosote was purchased under the following specification:

On account of the importance of this foundation it has been inspected frequently and carefully. Shipworm attack first appeared about 1920, or after 23 years' service, and the pile analyzed was removed in 1922, after 25 years' service.

FIG. 29—PILE SECTION WITH 16 LB. CREOSOTE TREATMENT. 25 YEARS' SERVICE IN 150 TON CRANE FOUNDATION, NEWPORT NEWS SHIPBUILDING & DRY DOCK CO., NEWPORT NEWS, VA.

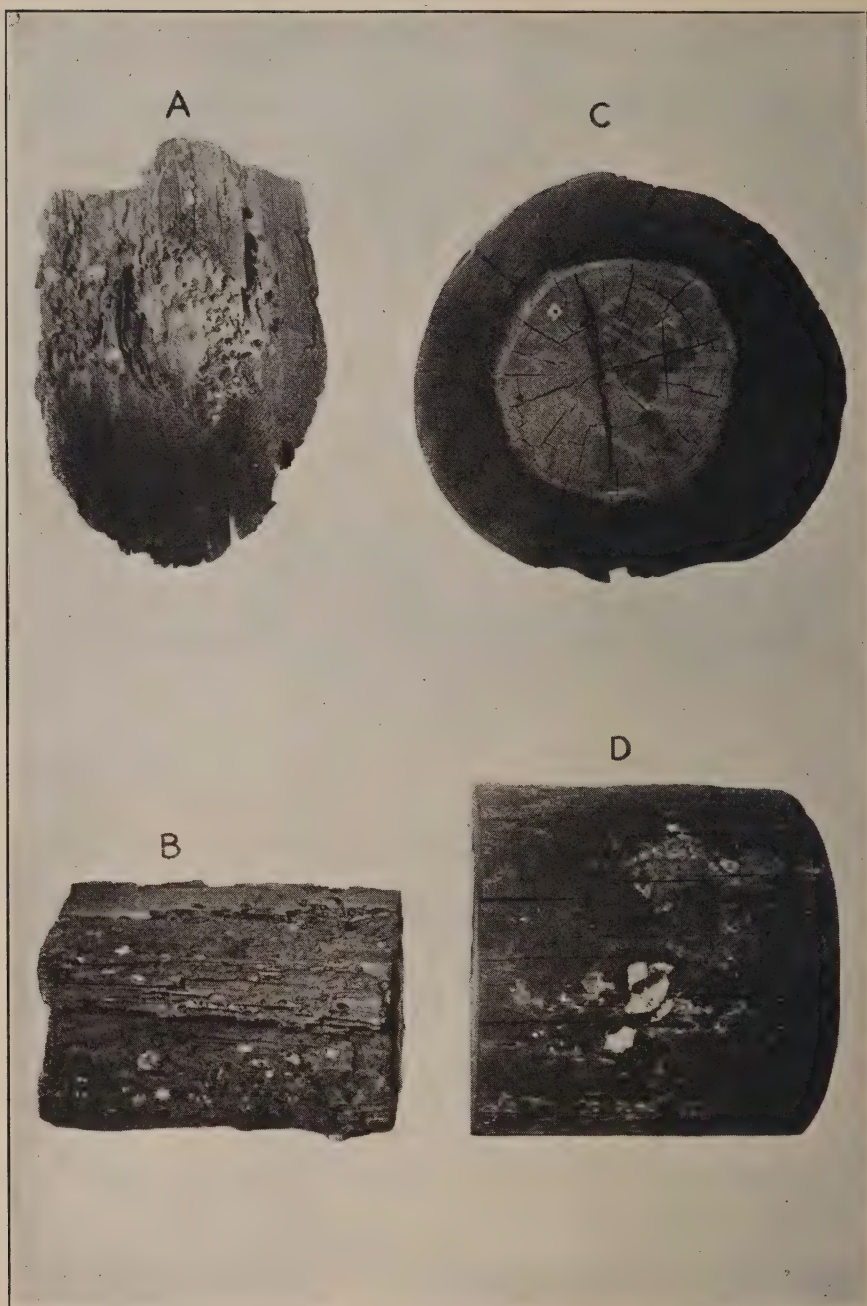
Specimen No. 1—Attacked slightly by *Limnoria* on one side and slightly roughened in few spots possibly by contact with boats. The pile otherwise was in an excellent state of preservation. The specimen had evidently developed slight cracks since it was cut. There were no borer holes. (Fig. 30.)

FIG. 30—PILE SECTIONS FROM TURTLE RIVER DOCKS, SOUTHERN RY.,  
BRUNSWICK, GA.

A. B.—Pile driven in 1909.  
C. D.—Pile driven in 1913.

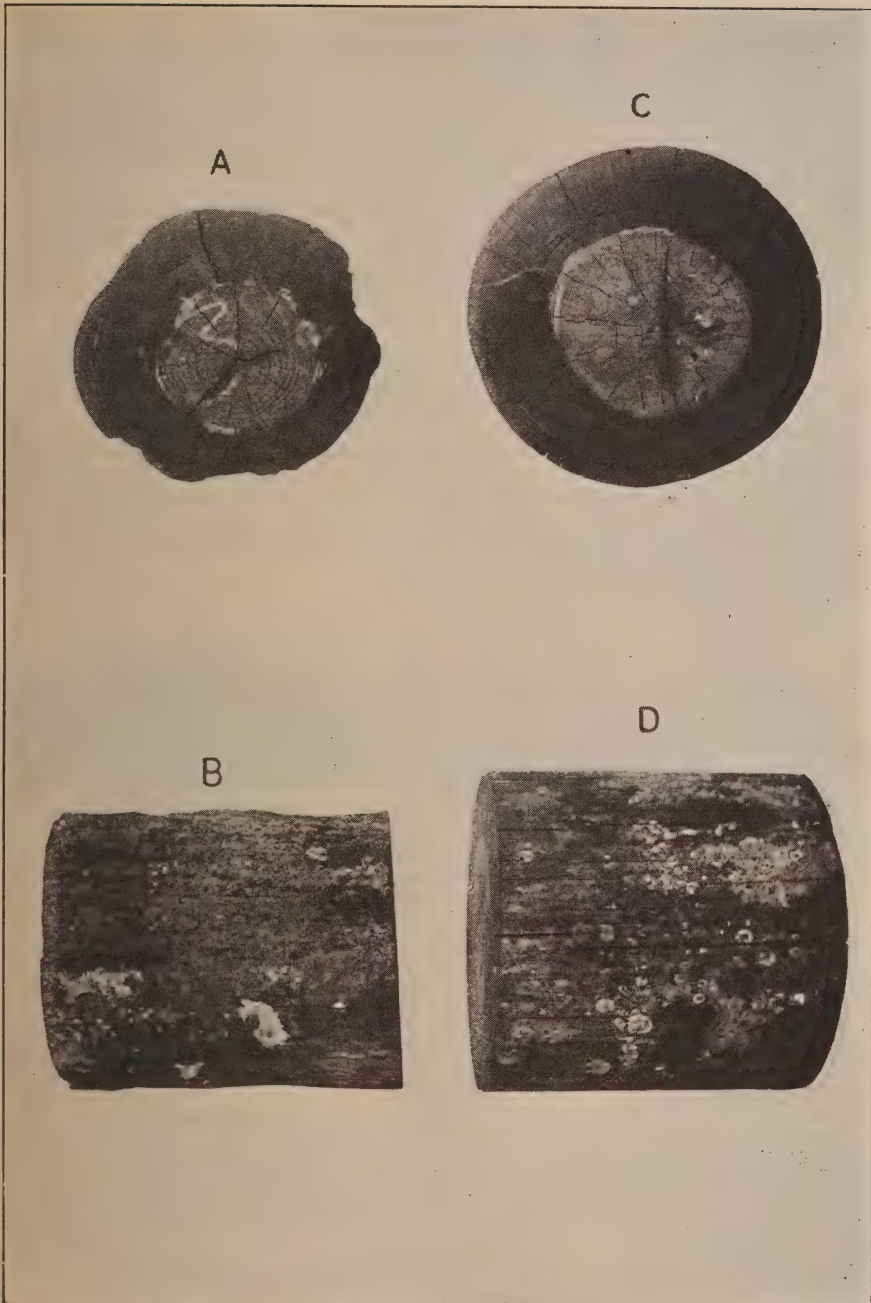
contained a few borer holes. Its surface was considerably indented from the results of the attack by *Limnoria*. (Fig. 31.)

FIG. 31—PILE SECTIONS FROM TURTLE RIVER DOCKS, SOUTHERN RY.,  
BRUNSWICK, GA.

A. B.—Pile driven in 1913  
C. D.—Pile driven in 1909

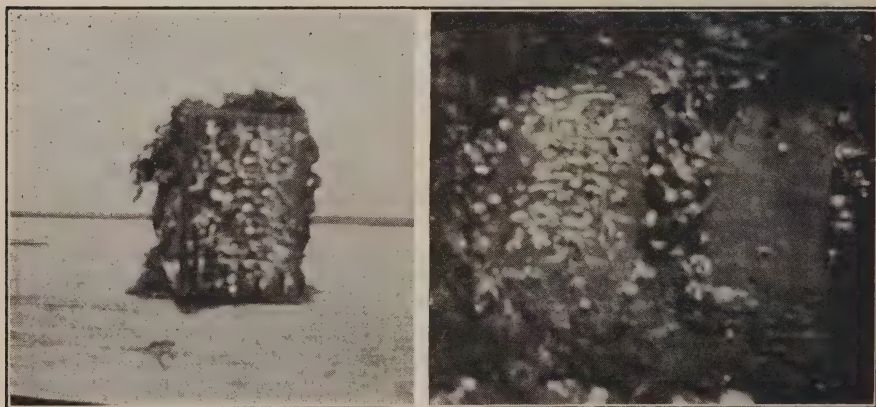
The accompanying small photographs demonstrate that the shipworm will cross a crack. (Fig. 32). The block (left) was removed from the base board (right) after three months' exposure. The face of the block in the picture shows distinctly that the borers passed through the base board into the block. It was observed at the Bureau of Fisheries Laboratory that shipworms frequently crossed gaps of at least 1/16-inch from one piece of wood to another, which fact shows the fallacy of the old belief that the *Teredo* will not cross a crack.

FIG. 32—SHOWING THAT SHIPWORMS WILL CROSS A CRACK

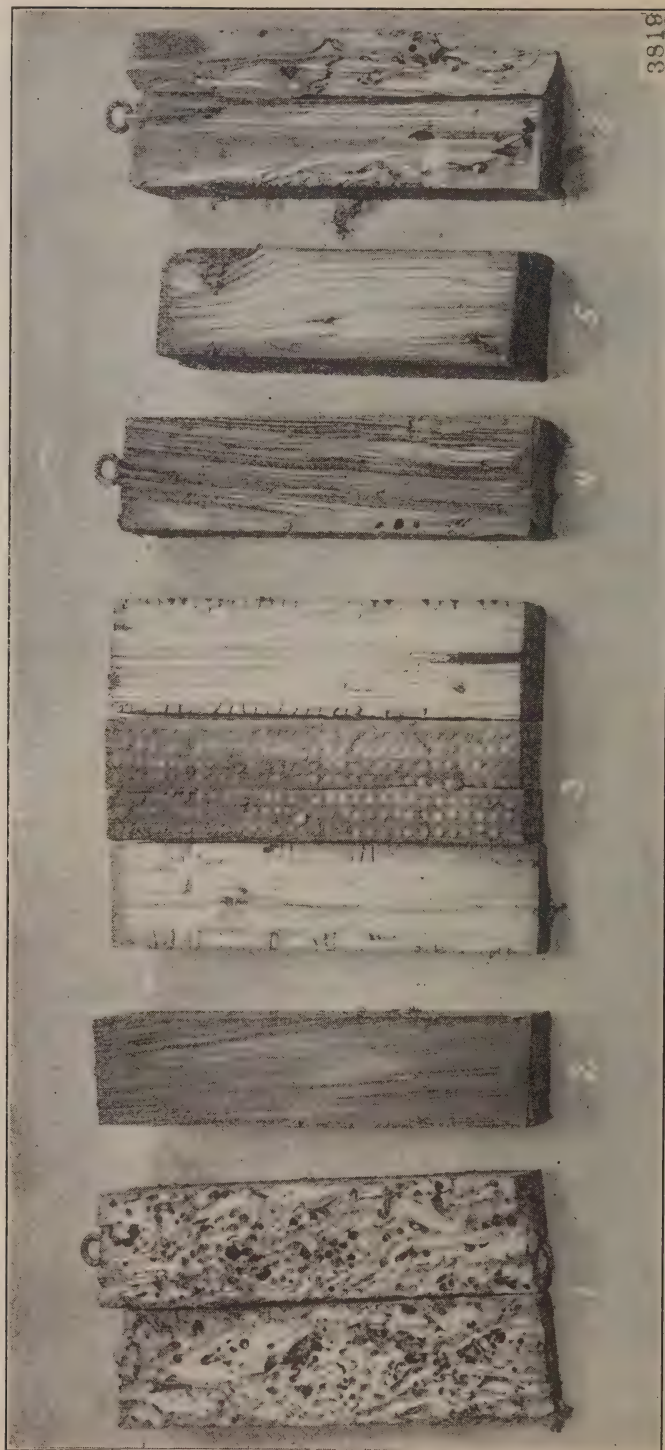
The accompanying photograph (Fig. 35) shows a longitudinal cross section of several of the test pieces after exposure. As will be noted, block No. 4 in this photograph is a straight creosote impregnation showing streaky impregnation in the heart wood, and slight *Teredo* attacks in this portion. Details of this piece are shown in the photograph (Fig. 36).

FIG. 35.—DETAILS OF SECTIONS OF TEST PIECES AFTER EXPOSURE (ONE-FIFTH ACTUAL SIZE)

- 1—Blank—no impregnant used.
- 2—Aczol impregnation.
- 3—Copper studded pieces.
- 4—Straight creosote impregnation.
- 5—Crystal violet.
- 6—Sulphur impregnation.

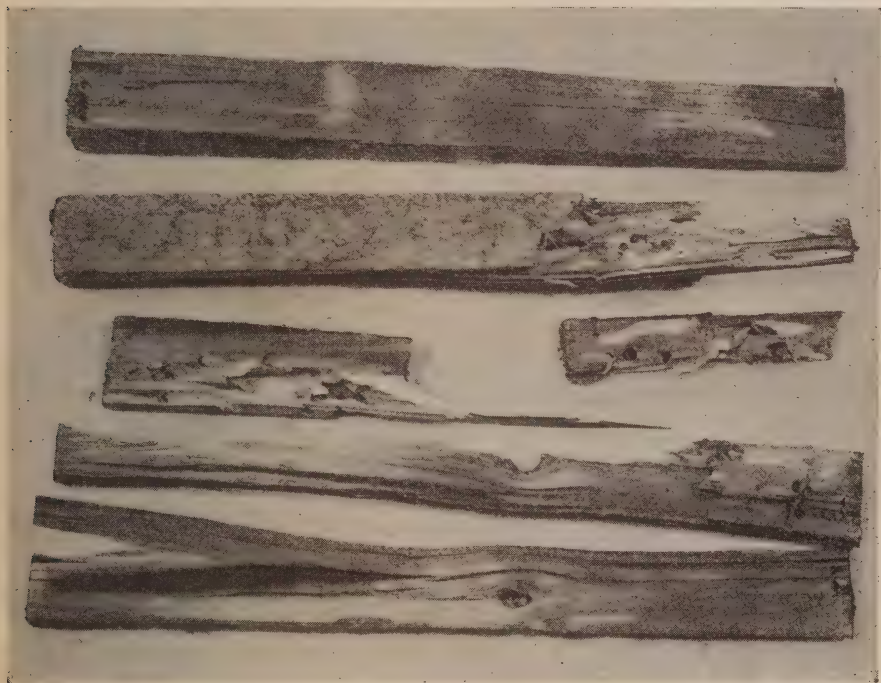
FIG. 36—DETAIL OF ATTACK ON CREOSOTED TEST PIECE

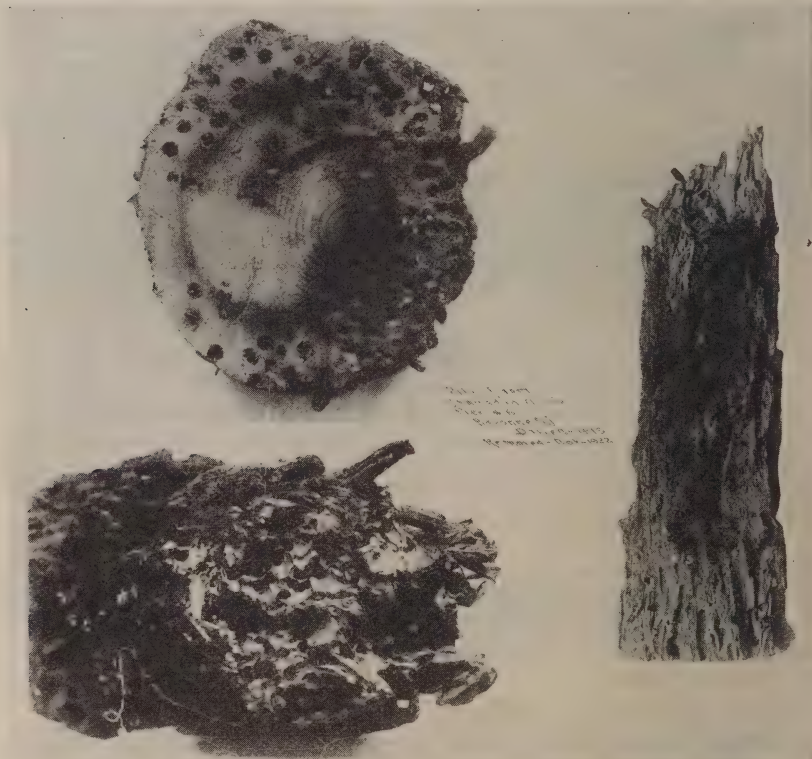
Pier 6, Standard Oil Company, Bayonne—Live specimens of *Teredo* were not found, but the borings were recent and some of the piles were practically destroyed by *Limnoria* and *Teredo* in five years, (Fig. 66).

FIG. 66—SECTION FROM A PILE DRIVEN IN STANDARD OIL PIER No. 6, BAYONNE, N. J., IN 1915 AND REMOVED IN 1922.

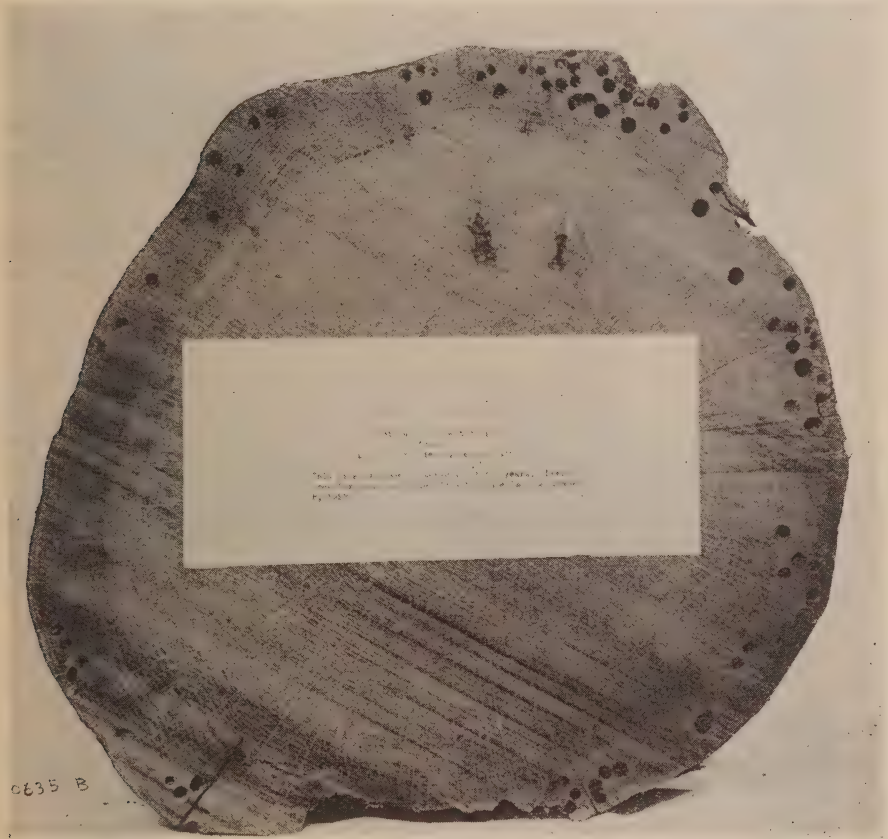
live in these locations, and this is confirmed by the finding of a few live specimens of *Teredo* in piles from the Wilson Line Pier at Hoboken and a larger number at Pier A (Fig. 67), of the Lehigh Valley Railroad at Jersey City, as well as old borings in piles from the Christopher Street Ferry and at Edgewater. *Limnoria* has been found at the Battery, West Fifty-second Street and Pier 22, North River, but not in great numbers.

FIG. 67—SECTION OF PILE FROM LEHIGH VALLEY RAILROAD PIER A, JERSEY CITY  
FROM WHICH LIVE *Teredo Navalys* WERE EXTRACTED

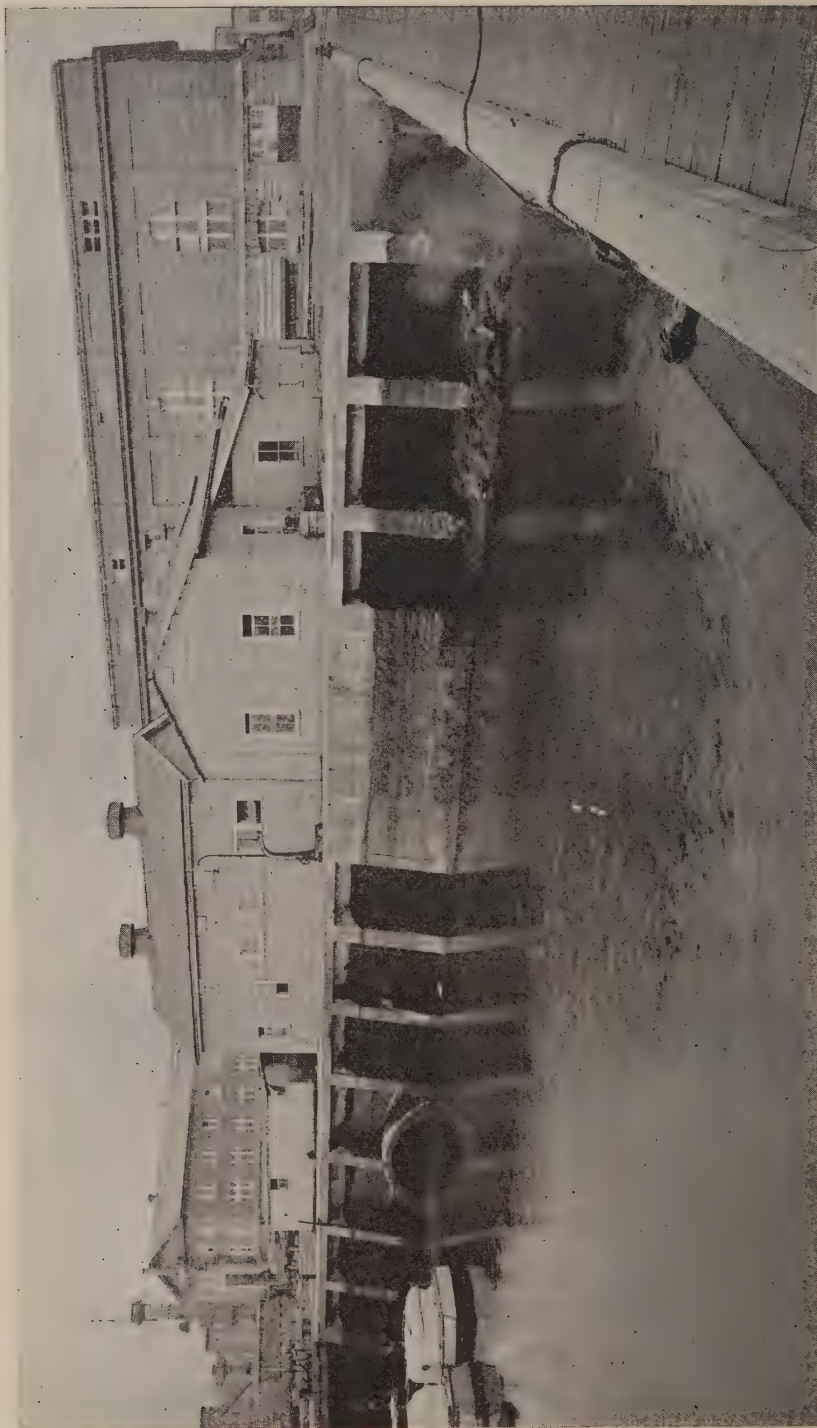
The mixture was 1:3:6 with a 1:2 mortar facing. The lower 6 feet of the wall was placed in the dry, but the tide frequently covered the remainder, which was carefully cleaned and grouted before recommencing work. The wall has been repaired at various times, and in March, 1923, showed considerable deterioration.

FIG. 144—SEAWALL SECTION, PUGET SOUND NAVY YARD, SHOWING CONCRETE DISINTEGRATION

Several other walls and structures are reported, but generally of the same type of construction and in about the same condition (Fig. 144).

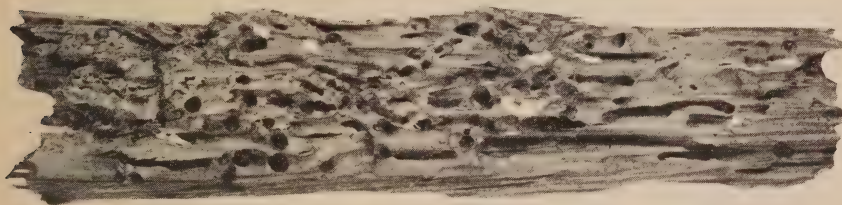
Since the preparation of this report Mr. R. T. Betts, chairman of the committee, received from Mr. Allen Spooner of Allen N. Spooner & Co., Inc., a section of the pine timber cover plates from the outlet nozzles of the Passaic Valley sewer, which terminates in the channel near Robbins Reef Light in a depth of 40 feet below mean low water.

Mr. Van Duyne, Chief Engineer of the Passaic Valley Sewerage Commissioners, states that this timber was new when installed and that it has been in place not more than four years. The cover plates were tem-

FIG. 169—SECTION FROM COVER PLATES OF PASSAIC OUTLET SEWER NEAR  
ROBBINS REEF LIGHT, NEW YORK HARBOR

porary, screw bolted to a cast iron nozzle and placed in such a manner that broken stone filling could be put around the nozzles for support. They lay in a horizontal plane, the nozzles pointing upward.

The section shown in the illustration (Fig. 169) is from the plank joining the cover plates and was removed May 31, 1924.

As may be seen from the illustration, the damage by shipworms was quite heavy and as it occurred in what by some has been considered territory free from serious attacks by marine borers, the information is thought to be of sufficient importance to justify its being appended to this report.
